ENABLED IMPACT PROJECT UPDATE

PROJECT: WYOMING HIGH SCHOOL RAIN GARDEN

PROJECT PARTNER: WYOMING HIGH SCHOOL BOARD OF EDUCATION

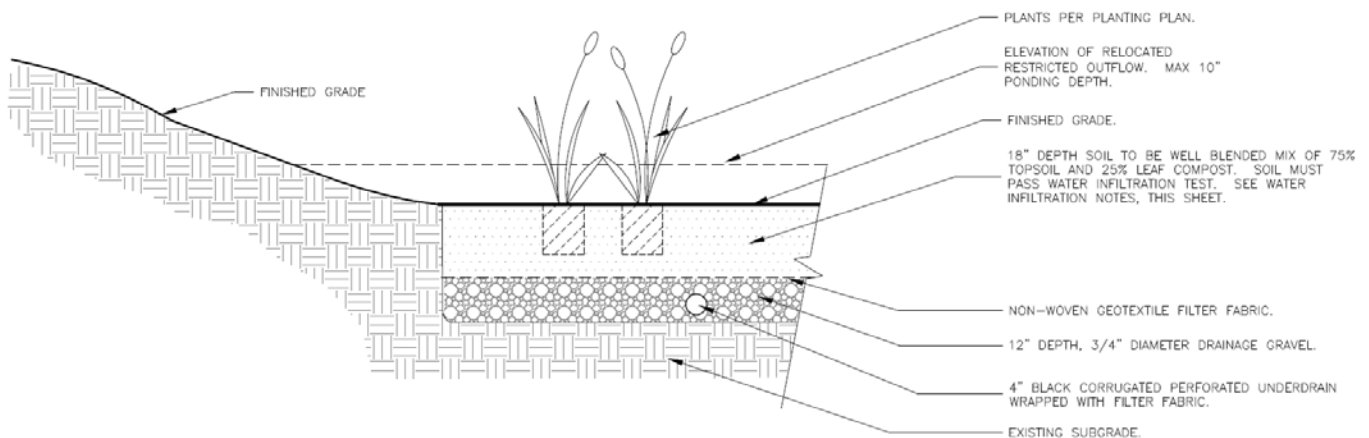
Typical Cross Section

RAIN GARDEN ELEVATION 601.40
 4" PERFORATED AT 0.5%
 INV 602.08
 INV 602.04
 599.13 AT STRUCTURE

The footprint of the 1,500 square foot rain garden sits at the lowest point of the pre-existing detention basin. Modifications to the outfall and overflow structure were made to allow for 10 inches of ponding in the proposed rain garden. There was no sand used in the soil mix for the feature. The underdrain ties back into the combined sewer system. The tributary area of the rain garden consists of two parking lots, an access road, the eastern rooftop area of the school, and adjacent lawn areas. The location of the rain garden utilized the site of an existing detention basin and outfall structure.

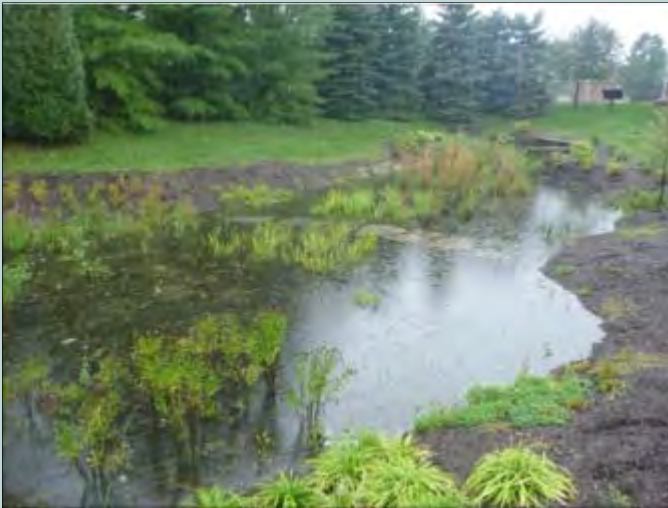
Stormwater ponded in the bioinfiltration basin during a rain event.

The soil mix proposed for the Wyoming High School rain garden included a combination of 75 percent topsoil and 25% leaf compost, which is different than typical soil mixes that include high percentages of sand. Despite the different soil mix, initial percolation tests after placement of the soil indicated an infiltration rate of 0.5 inches per hour, which was the minimum design infiltration rate. Based on observations during and after rain events, the rain garden appears to be draining as designed. The different soil mix presents a good case study that should be monitored over a longer period of time.

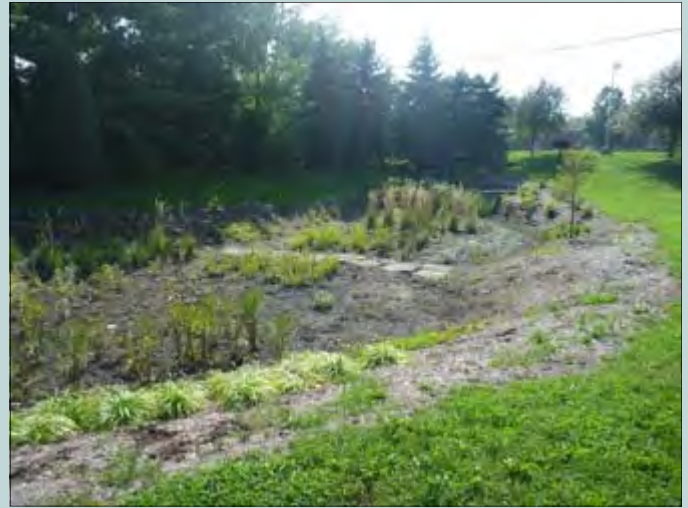
The stormwater has infiltrated through the system 24 hours after the rain event.
